## Field Observation Report

<b>FIELD OBSERVATION REPORT #:</b>	<b>03</b>	
<b>OBSERVATION DATE/TIME:</b>	December 3, 2021	10:30 AM
<b>REPORT DATE:</b>	December 10, 2021	
<b>PROJECT:</b>	<b>4600 Silver Hill Rd Parking Garage</b>	
<b>WALTER P MOORE PROJECT NO.</b>	D01.20007.00	
<b>WEATHER:</b>	Cloudy / Temperature 45°F	
<b>PRESENT AT SITE:</b>	Nouha Javed (b) (6)	Walter P Moore (WPM) Terra Site
<b>DISTRIBUTION LIST:</b>	Nouha Javed Chris Pinto Matt Heringer (b) (6) Andre Thomas (b) (6)	WPM WPM WPM Terra Site Terra Site GSA Davidson Brown Cinnovas

Project Name:  
4600 Silver Hills Road Parking Garage  
Expansion Joint Repairs

<b>FIELD OBSERVATION REPORT #:</b>	<b>04</b>	
<b>OBSERVATION DATE/TIME:</b>	January 24, 2022	10:00 AM
<b>REPORT DATE:</b>	January 25, 2022	
<b>PROJECT:</b>	<b>4600 Silver Hill Rd Parking Garage</b>	
<b>WALTER P MOORE PROJECT NO.</b>	D01.20007.00	
<b>WEATHER:</b>	Sunny / Temperature 35°F	
<b>PRESENT AT SITE:</b>	Nouha Javed (b) (6)	Walter P Moore (WPM) Terra Site
<b>DISTRIBUTION LIST:</b>	Nouha Javed Chris Pinto Matt Heringer (b) (6) Andre Thomas (b) (6)	WPM WPM WPM Terra Site Terra Site GSA Davidson Brown Cinnovas

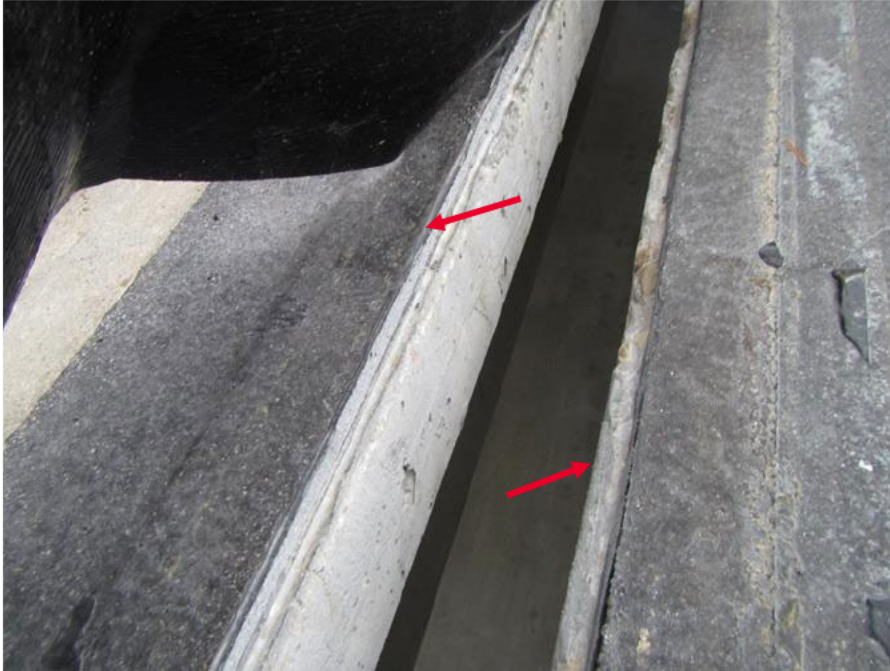
- 03-1. The widths of elastomeric concrete headers at the existing expansion joint block-outs were observed to be inconsistent in the North, South and Middle garages. At these locations, the header edges were not flush with the concrete slab edge below as needed for joint installation (Photo 03-1 and Photo 03-2). WPM noted the approximate quantities required for the repair of the joint headers (see EX-1 attached).

**03-1** Tapered edge of the elastomeric concrete header at the roof level of the North garage

*Action: Contractor to restore elastomeric concrete header edge to the floor surface as required.*

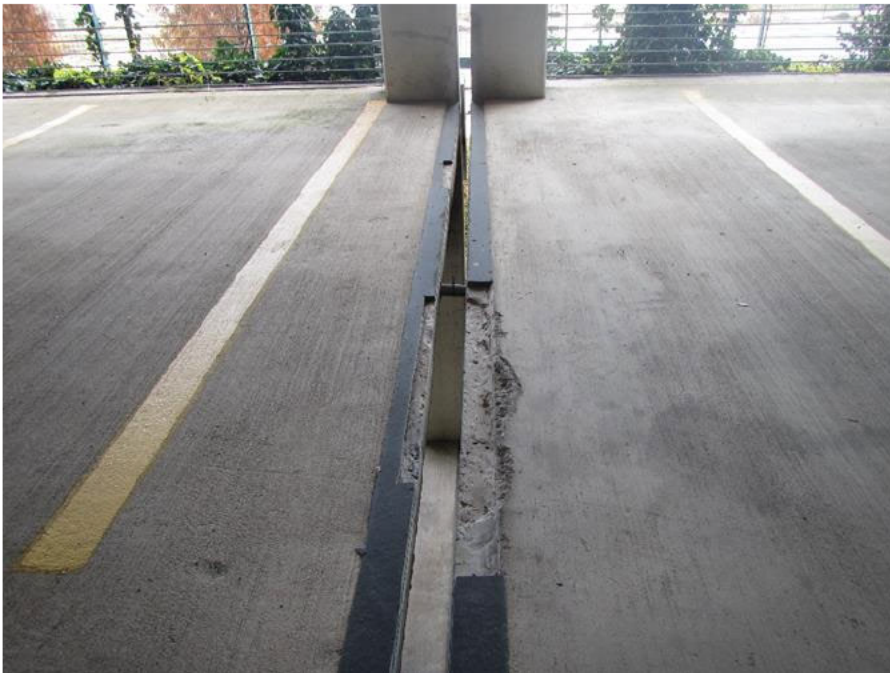
**03-2** Modified elastomeric concrete headers at Level 2 of the North garage

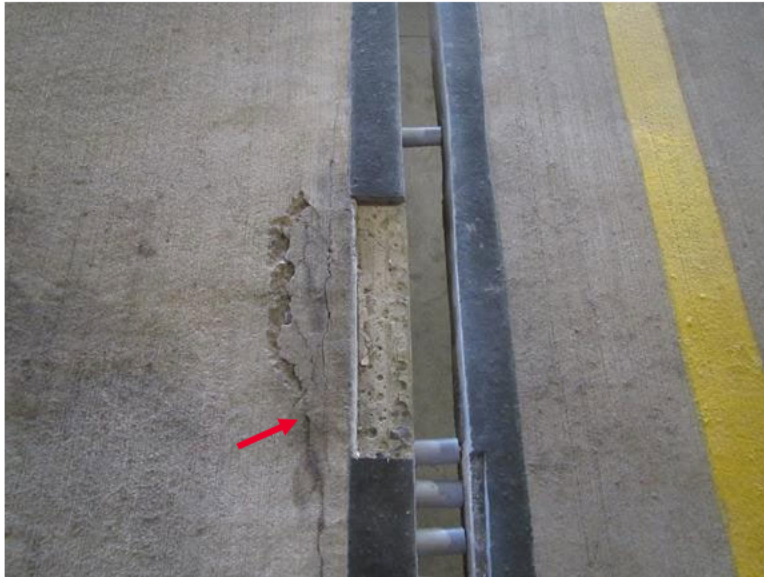
03-3

- 03-2. WPM observed isolated locations of concrete slab spalling at Level 2 (gridlines A-B) and Level 1 (gridlines C-D) of the North garage (Photo 03-3). Additionally, concrete slab cracking was observed at Level 2 (gridlines C-D) of the North garage (Photo 03-4).

Isolated location of concrete slab spalling at Level 1 of the North garage

*Action: Contractor to sound locations of concrete distress for extents of slab delamination. Remove deaminated concrete and repair with an appropriate cementitious material.*

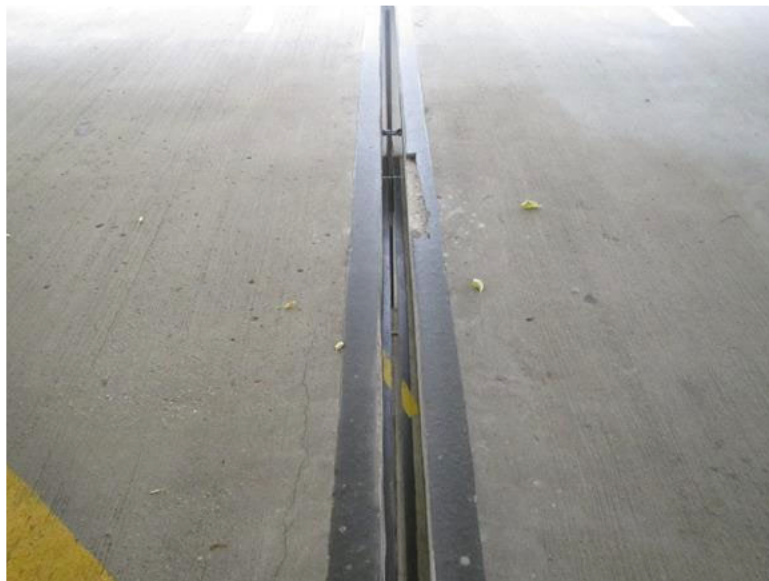
03-4

Isolated location of concrete slab cracking at Level 2 of the North garage

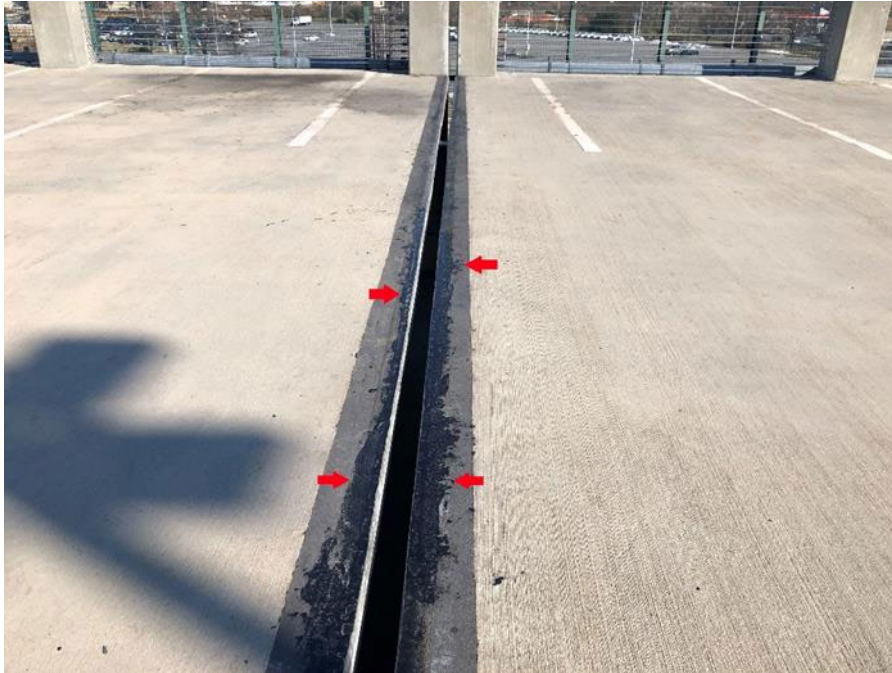
- 04-1. Elastomeric concrete header repairs were typically observed at all levels of the north, south and middle garages (Photo 04-1 through Photo 04-4). The completed repairs were typically sound and flush with the existing header material and block-out.

**04-1** Typical completed elastomeric concrete header repairs at the roof level of the south garage

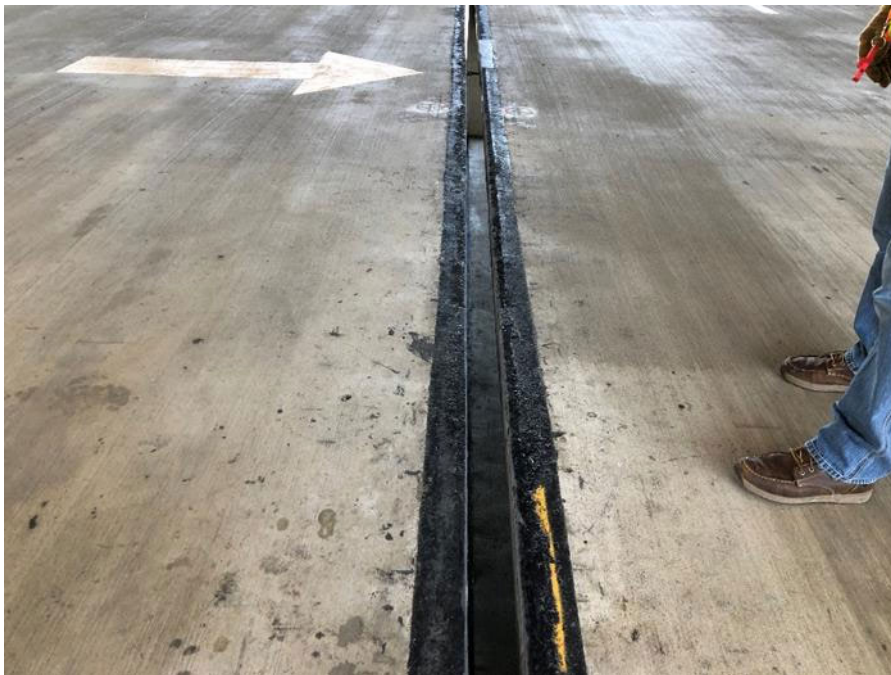
**04-2** Typical completed elastomeric concrete header repairs at the Level 4 of the south garage

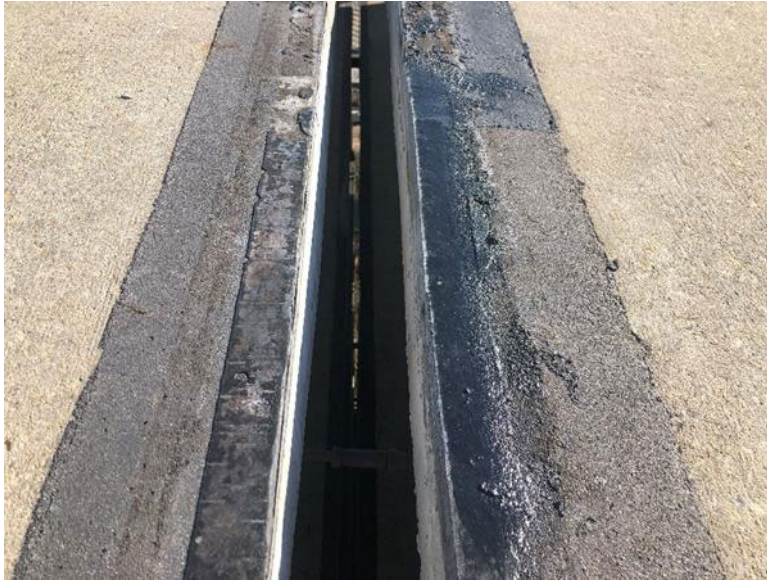
04-3

Typical completed elastomeric concrete header repairs at the roof level of the north garage

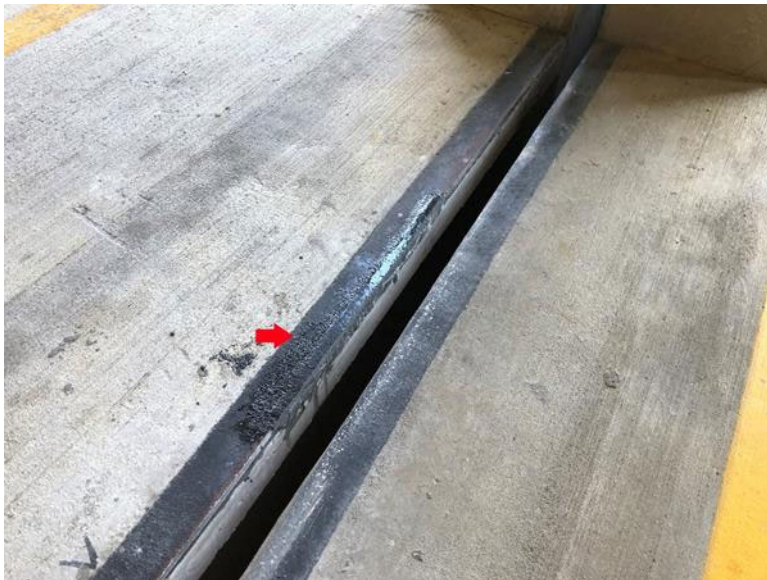
04-4

Typical completed elastomeric concrete header repairs at the Level 1 of the middle garage

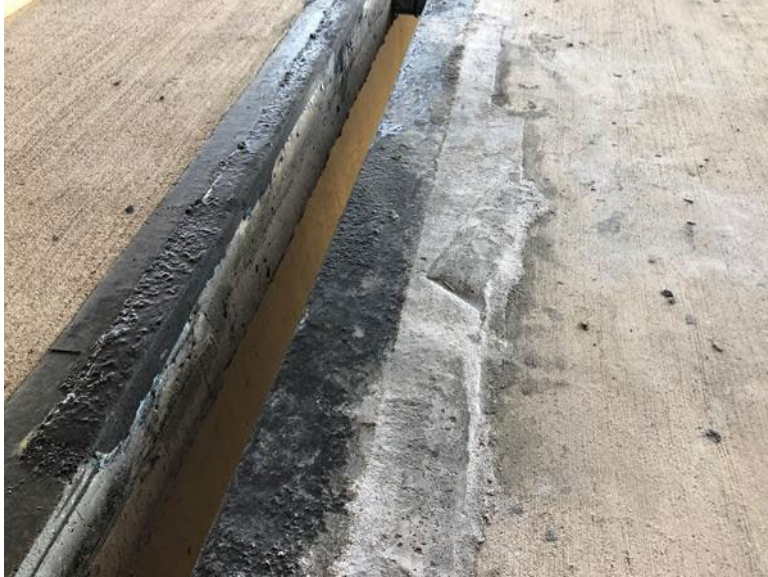
04-5

- 04-2. Isolated locations of partial-depth concrete slab repair were observed at Levels 1 and 2 of the north garage (Photo 04-5). The repairs were observed to be sound, flush with the existing slab surface and to have squared edges.

Typical completed concrete patch repair at Level 2 of the north garage

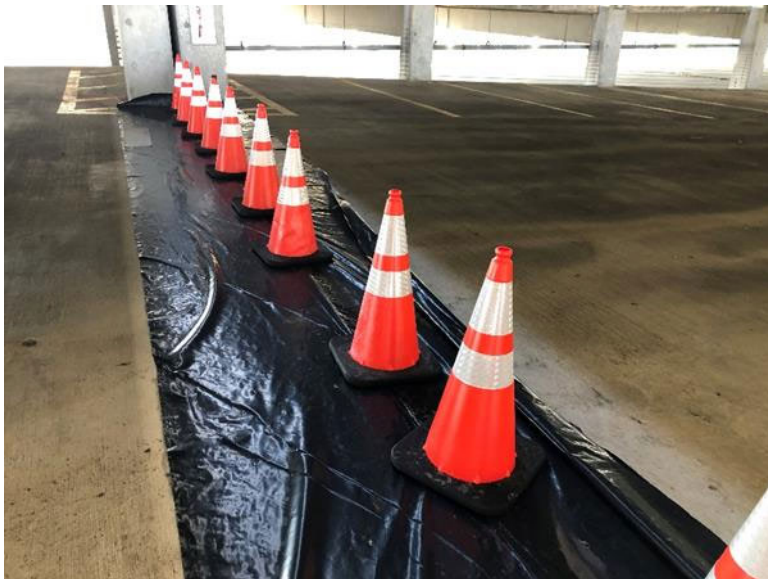
04-6

- 04-3. Weather-proofing was observed at the Level 4 ramp of the north garage and the Level 4 ramp of the south garage, to prevent water ingress through the roof level expansion joint block-outs (Photo 04-6). The weather-proofing typically consisted of adhesive membrane strips and plastic sheeting.

Typical weather proofing installed at the Level 4 ramp of the south garage
